## **Dye Penetrant Inspection Technique of Turbine Rotating Component**

Alexander Nana Kwesi Agyenim-Boateng<sup>1</sup>, Edward Kumi Diawuo<sup>2</sup>, Psalmiel Nana Nti Agyei<sup>3</sup>

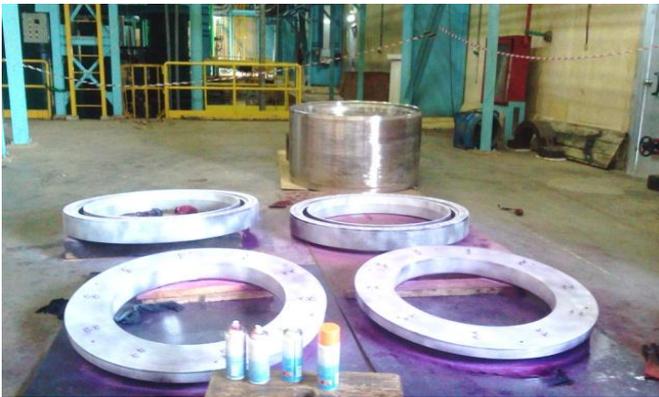
*Fig -1: Generator fan Assembly rings pre-cleaned*

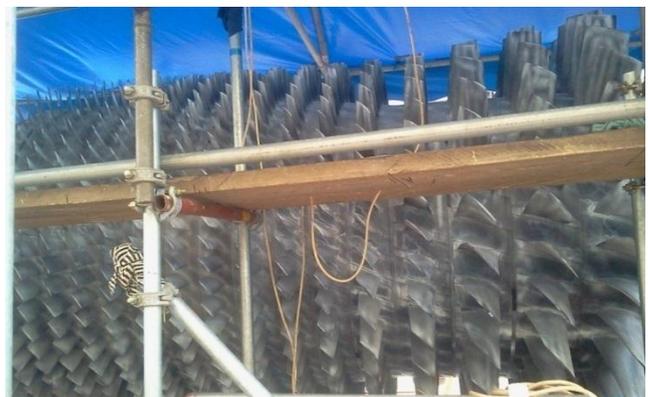
*Fig -2: Compressor rotor pre-cleaned*

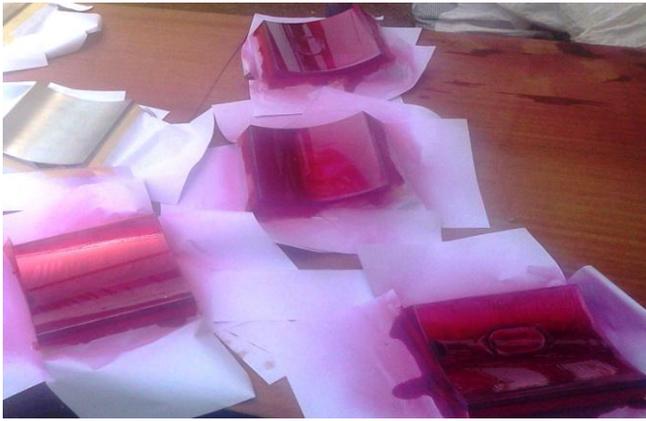
*Fig -3: Applied red dye on generator bearings rings*

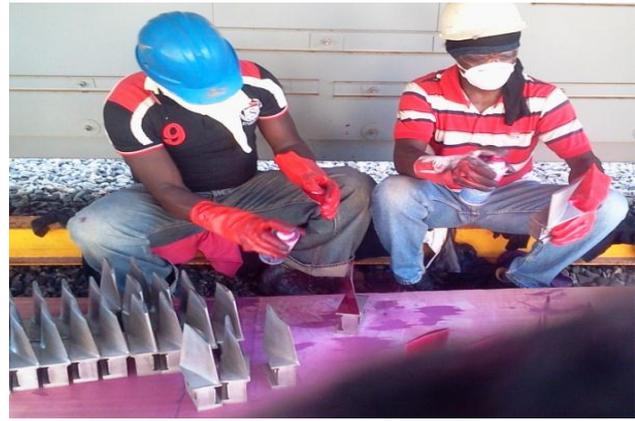
*Fig -4: Red dye on rotor exciter end fan blade*

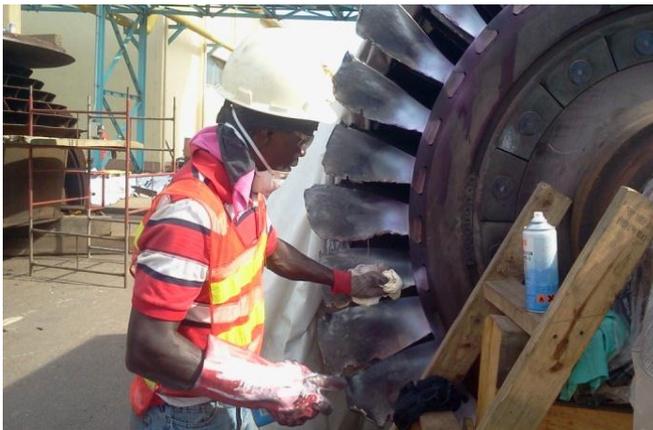
*Fig -5: Cleaning of Compressor Rotor*

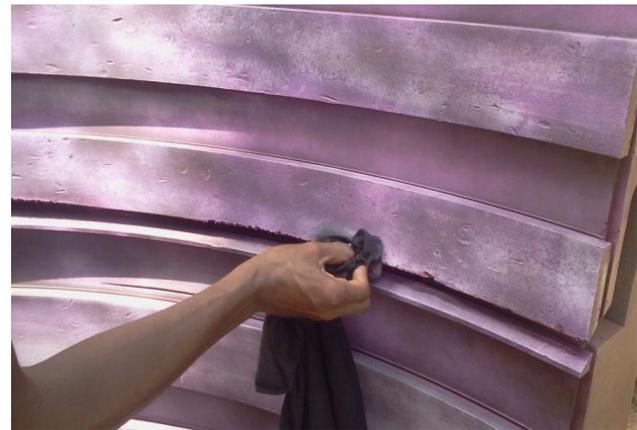
*Fig -6: Cleaned Upper half Compressor*

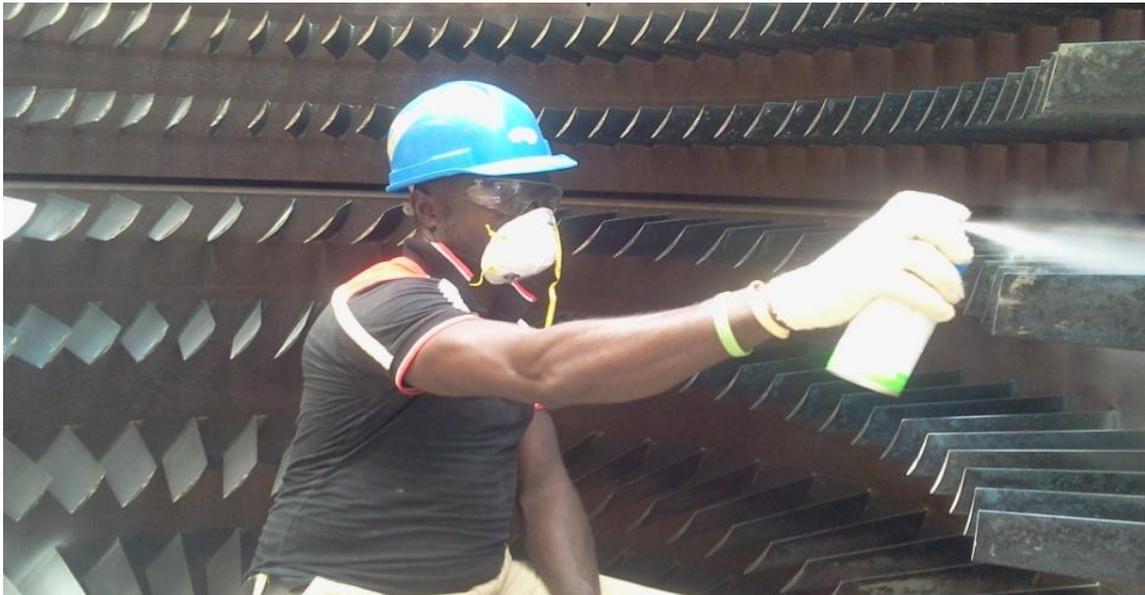
*Fig -7: Application of developer on the upper half of compressor casing*

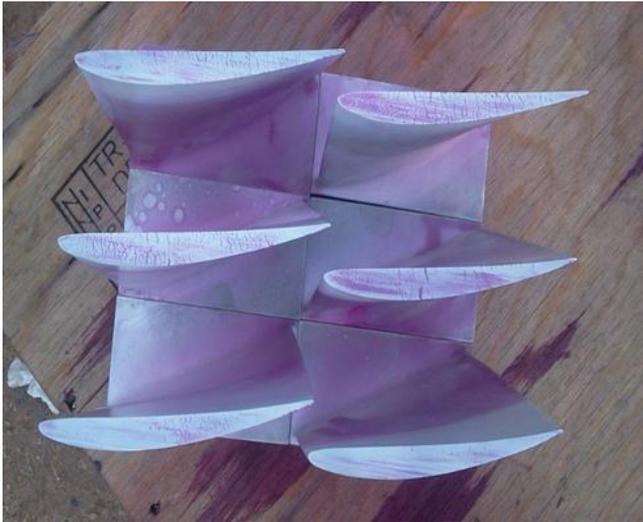
*Fig -9: Scattered cracks on Generator rotor Exciter*

There were also scattered cracks on the generator rotor exciter fan blades and heat treat cracks on the compressor upper half discharging casing. All other examinations conducted on the diffuser, the generator bearings and the generator retaining rings showed no defect, also there were no sign of foreign bodies in the turbine casing.

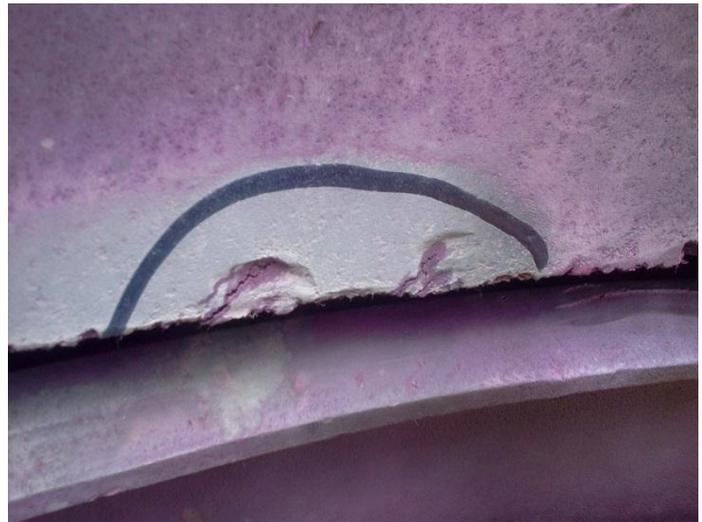
*Fig -10: Heat treat cracks on Compressor upper half fan blade*

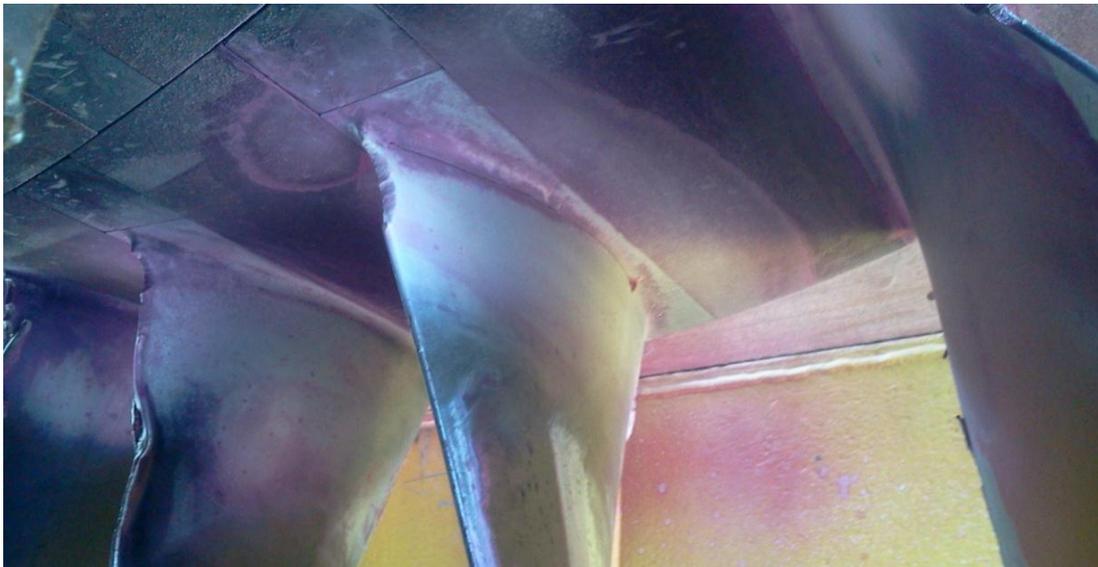
*Fig -11: Fractured and Fatigue cracks on Generator Rotor Exciter end fan blades*

The various parts of the steam turbine evaluated were both the compressor and generator rotor, turbine blades, the diffuser, the exhaust hoods, the compressor casings, the generator bearings and retaining rings. The dye penetrant testing basically revealed the cracked, fractured and sound parts of the steam turbine blades which did not completely fracture during the accident. Visual inspections of the defective turbine blades indicated the various categories of flaws; these are fractured parts, grinding crack, heat treat crack, and fatigue crack. All these discontinuities are related to the various service conditions these components are subjected to. Grinding crack is a processing-type discontinuity caused by stresses which are built up from excess heat created between the rotary wheel and the adjoining metal. The heat treat cracks are often caused by the stresses built up during heating and cooling. Unequal cooling between light and heavy sections may cause heat treat cracks to emerge. It usually has no specific direction and usually opens to the surface where they start from concentration points. Fatigue cracks are usually open to the surface where they start from

concentration points and may be as a result of porosity, inclusions or other discontinuities in a highly stressed metal part. The results illustrated in table 1 indicates various categories of defects and their respective blade numbers.
