Rework in Building Projects: Lessons from case studies

Case 1:-Rework due to deficiency in old and new sanctioned project plan.

Case2:- rework happened due to change in owners decisions.

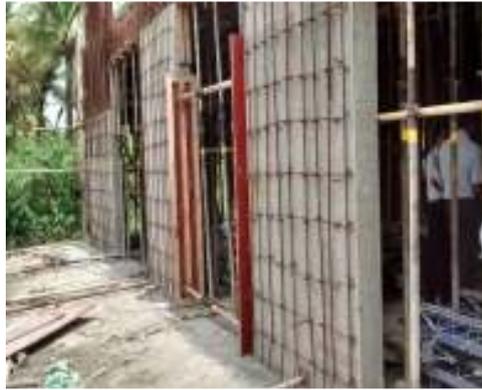
Figure.1 Re-baring for columns

To bear the load of all above slabs on new floating columns and to transmit this all load on old columns, their section is increased by increasing width by 150mm throughout individual column length. The 16mm diameter Fe 415 steel is used as a vertical reinforcement and 8mm diameter Fe 415 as a distribution steel with the help of re-barring for below columns at two levels i.e. pile cap to first slab and first slab to second slab as shown in figure 1 below. These columns are re-casted for increased width with rich M.40 mix concrete as shown in figure 2 below.

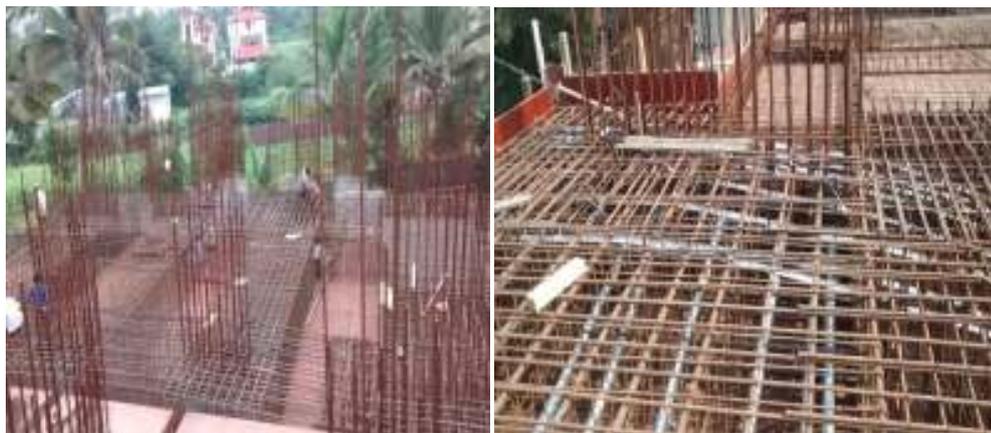
Figure 3 Heavy reinforcement and post tensioning treatment for slab.

RCC design for this slab comes out to concreting the whole slab for a uniform depth of 1200mm. To bear such a heavy dead load of concrete the special formwork for slab is designed and checked with consultant before casting. Steel design also consist of higher diameter 32mm Fe415 steel for all beam section and 16mm diameter Fe415 steel for slab in both ways at the top and bottom of 1200mm depth forming a double cage reinforcement. The slab is also subjected to post tensioning design by another special post tensioning design firm as shown in figure 3.

Concreting of slab is done with a rich mix of M.40 grade concrete in two layers. The first layer concrete thickness casted is 700mm and second layer thickness is 500mm casted on next day after final setting of first layer thus completing the total thickness of concrete i.e.1200mm. This is done in order to distribute the uniform load on shuttering below avoiding the sudden dead load of whole thickness as per consultants instructions. The builder experiences the total cost of rework about 12% of the construction phase cost in this case.

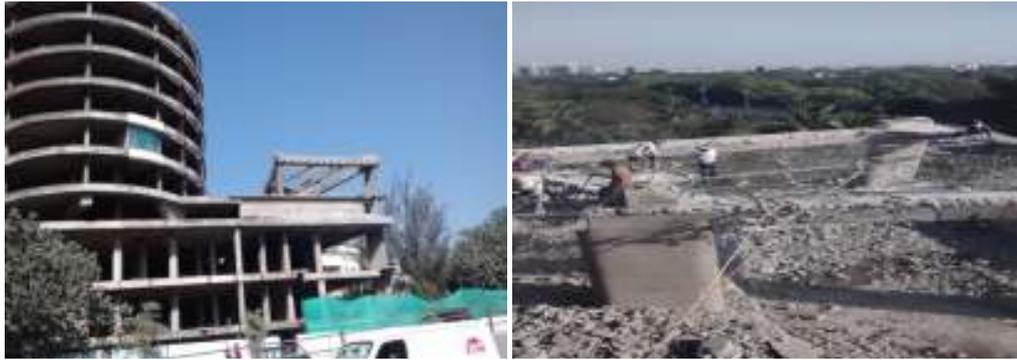
Figure 4 Dismantling of slabs.

In order to achieve maximum saving and minimizing loss of damage to the already built structure of RCC, the builder decided to unaltered the plan of lodging building which is eight storey structure by adopting no change in RCC super structure for that part. However there require a change of plan for dinning building which is four storied structure as per requirements of hospital authorities. The revised plan needed to combine the floors of two buildings which are constructed already with two different individual heights of floors. Thus according to new plan it requires to dismantle all four floors of dinning building and reconstruct them with keeping same height of individual floors as that of lodging building so as to form a combine structure. The management adopted this change and dismantled the four floors of dinning building as shown in figure 4
